MASS / RI COASTAL BASIN  
HOPKINTON, RHODE ISLAND

LOCUSTVILLE POND DAM  
RI 01408

PHASE I INSPECTION REPORT  
NATIONAL DAM INSPECTION PROGRAM

JANUARY, 1981

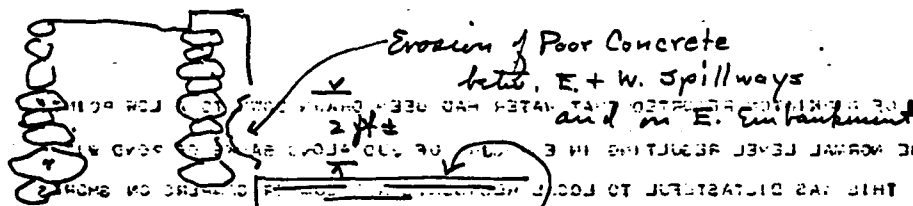
## Cross Section thru Dam

Present water level

1 1/2 - 2 ft. below crest of Dam

Location of latest repair (dam) also patch in face
